LVT Cosmetic Defect - Testing and Results:

In light of the recently-discovered cosmetic defect in our stock of Color LVT Film, we performed the following tests to ensure that these cosmetically defective targets provide accurate measurements.

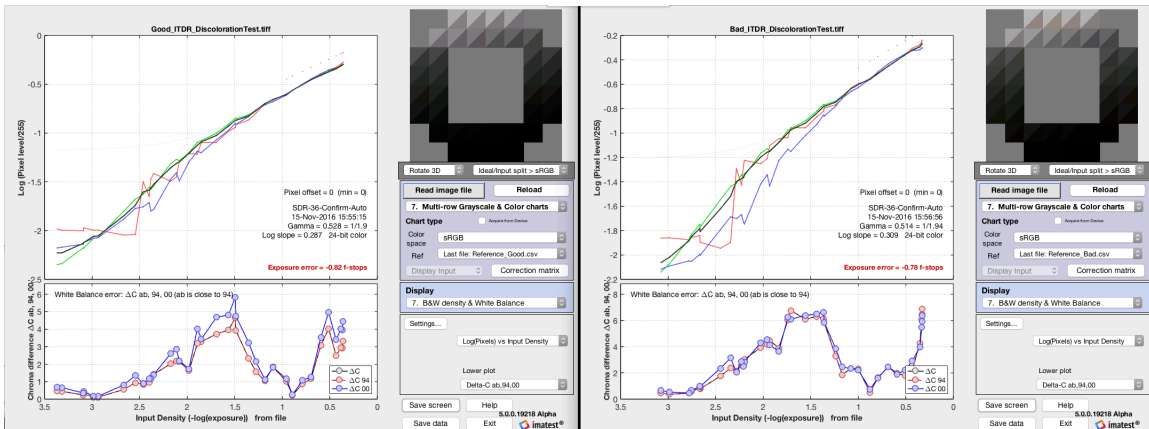
These images were both run through Imatest - Multicharts. The results of this test showed a 0.014 difference in the gamma measurement, which is well within the tolerance range for this test.

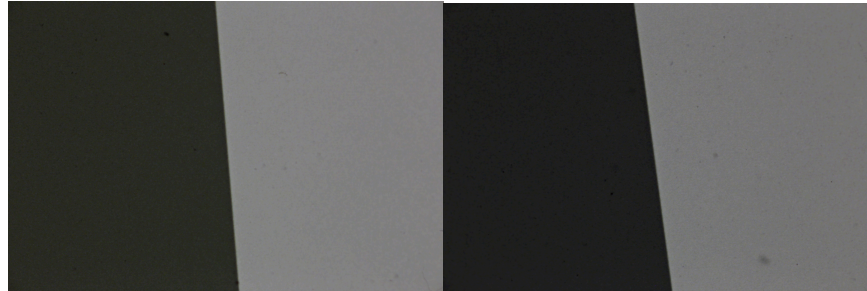
For this test, two images were captured under the same testing conditions, one using a target with the cosmetic defect, the other without. The images were captured in a corner region of the film where the defect had crossed over the slanted edge on the defective target. The same location from a flawless target was used for comparison. Both images were taken at 5x magnification on the sensor.

Left: Cosmetically Defective Target | Right: Flawless Target

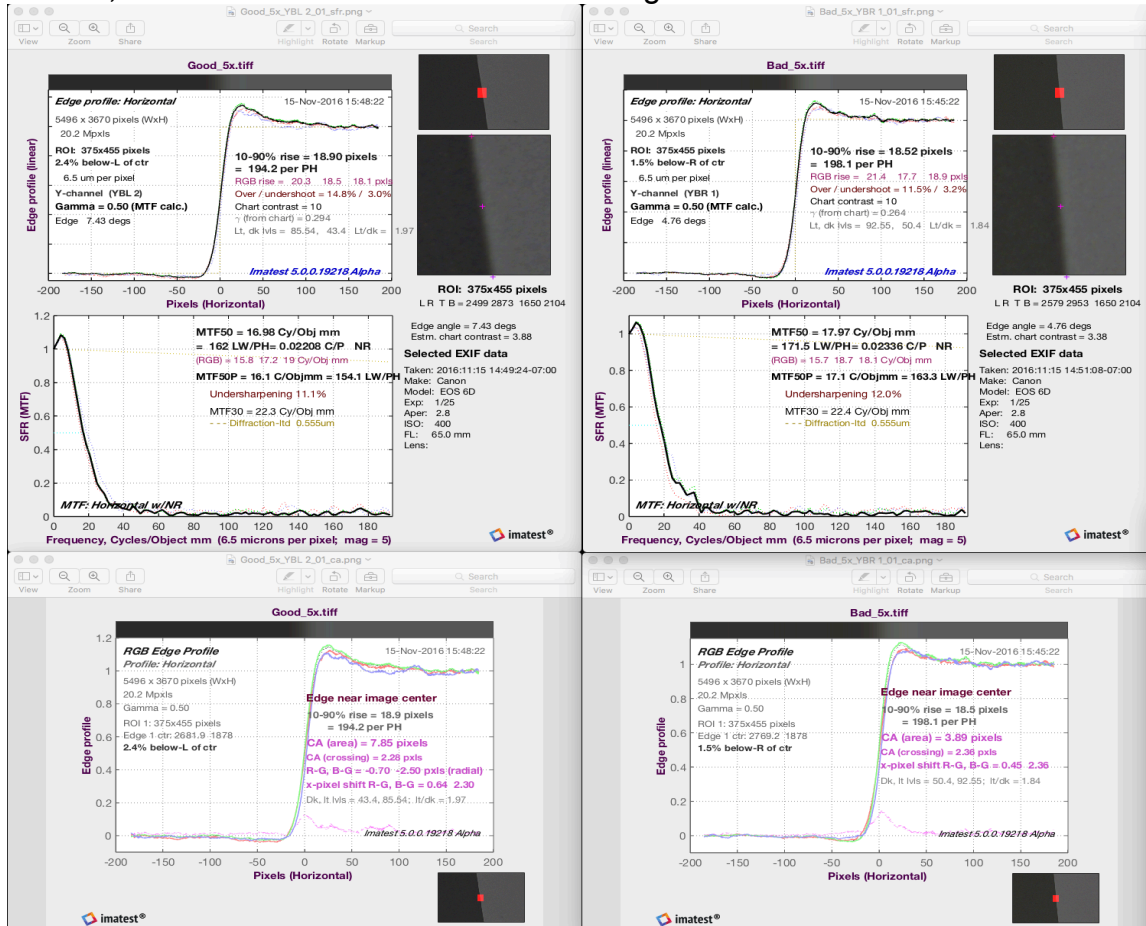
Both of these images were run through Imatest-Rescharts (SFR). The results of this test show a difference of 1 cycle per object millimeter (6%) in the print at MTF50, which is well within the tolerance range for this test.
